CASE STUDY ON THE USE OF ADVANCED PHASED ARRAY ULTRASONIC TESTING METHOD ON LIMITED ACCESS T-JOINT WELDS MADE OF P91 STEEL

Abstract: *This paper evaluates the performance of ultrasonic testing using the advanced Phased Array Technique (PAUT) applied to T-branch welded joints with unilateral access. The base material of the components forming the welded assembly is the thermally resistant martensitic steel grade P91 (9Cr1MoVNbN). The welding processes used to fabricate the assembly were TIG (Tungsten Inert Gas) for root pass deposition, and SMAW (Shielded Metal Arc Welding) for filling the joint. The quality assessment aimed to analyze the welding-induced imperfections, considering the known susceptibility of this material to creep failure during prolonged service at temperatures of 300–500°C, which can lead to aging effects, diffusion of chemical elements, and microstructural degradation. Due to geometrical constraints and limited accessibility imposed by the pipe system configuration containing the examined welded joint, a single-direction Phased Array Ultrasonic Testing (PAUT) inspection (unilateral scan) was selected. Consequently, the inspection represents a deviation from the

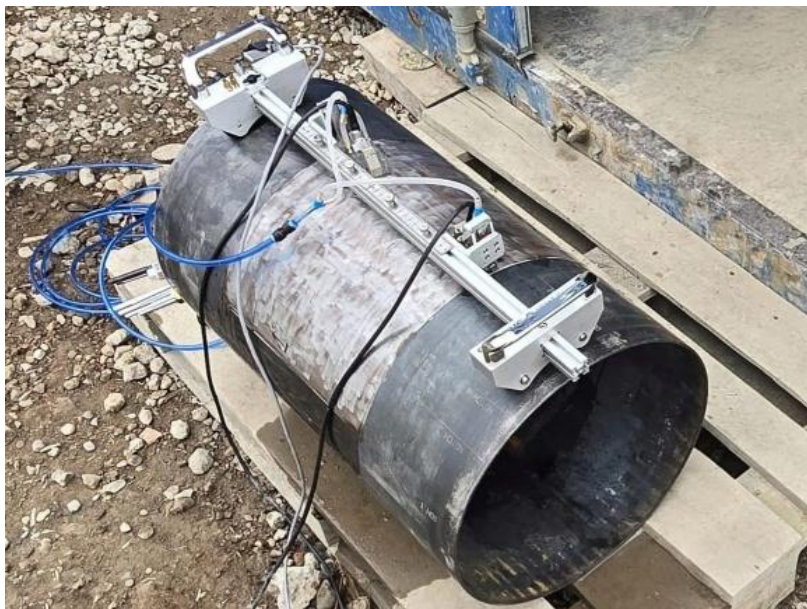
Table 4 presents the required reflectors for a single-sided examination, including their theoretical dimensions and the actual dimensions achieved after mechanical preparation, Figure 4 shows the actual reference block, and Figure 5 shows the positioning of the reflectors on the qualification block, referenced to the imaginary weld central axis.

Figure 4. PAUT qualification block

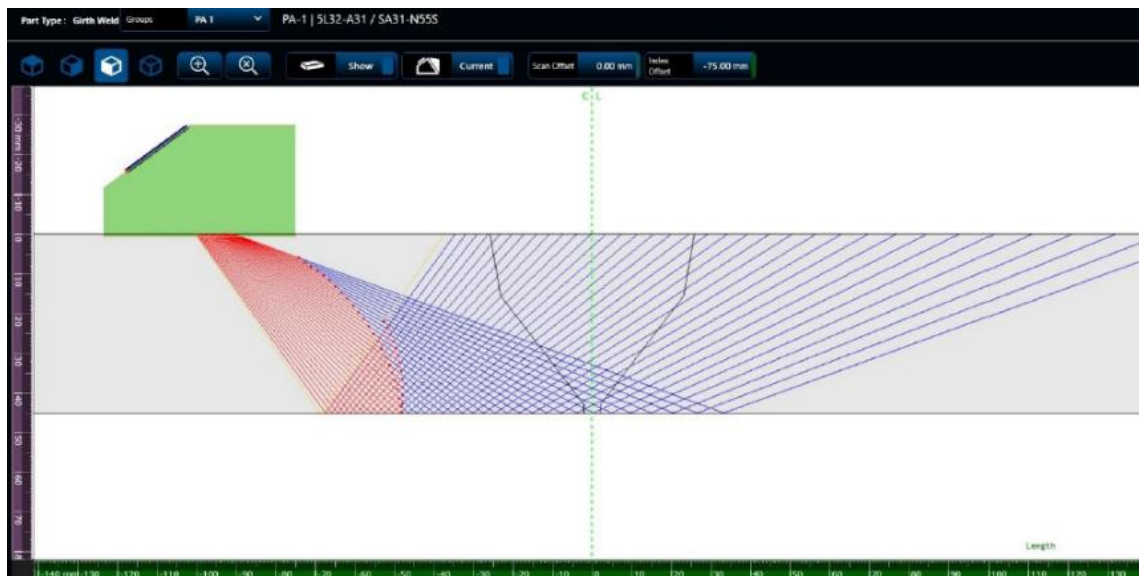
Prior to the actual examination, the ultrasonic flaw detector was calibrated using a dynamic calibration block. Subsequently, a setup was generated to ensure full coverage of the entire weld inspection volume (Fig. 6). The inspection was then validated using a qualification block, which highlighted discontinuities present both at the surface and within the volumetric section.

Figure 6. The setup used for single-sided scanning

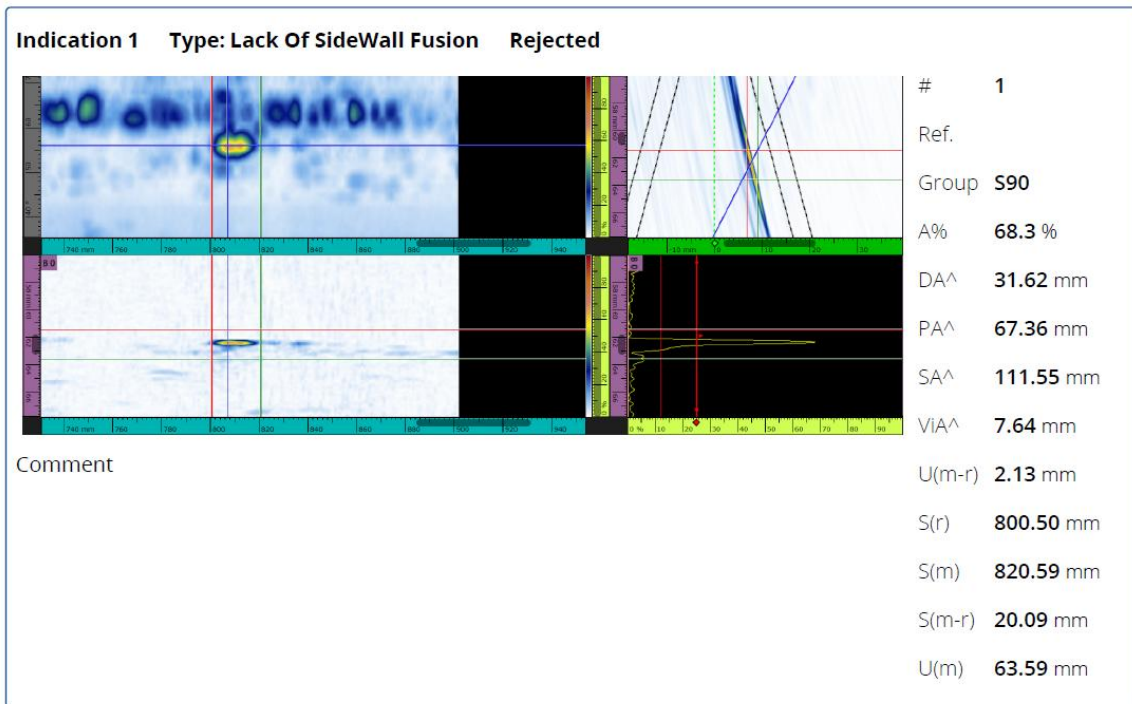
The examination identified a lack of sidewall fusion (LOSF) imperfection located on the far side of the weld, opposite to the probe position. Based on the evaluation of the defect response and in accordance with the acceptance criteria of ASME B31.1, the indication exceeded the permissible limits and was consequently classified as a defect, exhibiting the characteristics listed in Table 5. Figure 7 presents the examination software image of the defect.

Figure 7. Examination software image of the defect

Based on the values presented in Table 5, the indication identified during the single-sided Phased Array ultrasonic examination exhibits dimensional and response characteristics relevant for evaluation in accordance with the applicable acceptance criteria.

The maximum recorded amplitude of 68.3% indicates a significant ultrasonic response, suggesting the presence of a discontinuity with high reflectivity, consistent with a lack of sidewall fusion (LOSF) imperfection. The absolute depth value of 31.62 mm confirms that the defect is located approximately in the mid-thickness region, on the far side of the weld relative to the probe position, which is typical for limited-access configurations with single-sided scanning.

The sound path length of 67.63 mm and the surface distance/sound path projection of 111.55 mm are consistent with the calculated beam trajectory for the refracted angle used in the Phased Array setup, validating the spatial positioning of the indication with respect to the T-joint geometry. Correlation of these parameters enables precise localization of the defect in both the cross-sectional and longitudinal planes.

The vertical indication amplitude of 7.64 mm reflects the estimated through-thickness extent of the discontinuity, indicating a pronounced development along the weld sidewall. This value, together with the relatively high signal amplitude, supports the classification of the indication as a rejectable defect according to the applicable acceptance criteria.

The excavation was carried out locally in the area indicated in Fig. 7 to a partial depth sufficient to visually expose the discontinuity without removing the entire ligament. The grinding profile was smooth and properly blended to avoid introducing artificial indications, in accordance with surface preparation requirements of ASME Section V, Article 6. This first excavation was intended solely to expose and confirm the presence of the defect.

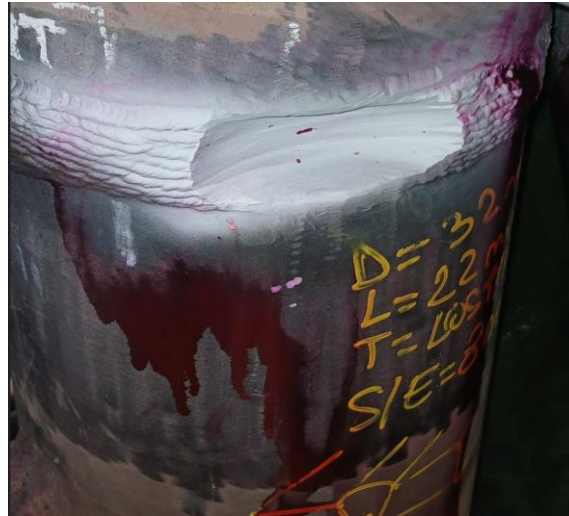
Overall, the parameters obtained from the examination confirm the presence of a structurally significant imperfection located on the far side of the joint relative to the probe position, demonstrating the effectiveness of the method in detecting and characterizing defects in limited-access T-joint weld configurations. To confirm the existence of the identified defect and validate the PAUT examination, penetrant testing (PT) was performed after excavation reached the indicated location, confirming the defect, as shown in Figure 8.

Figure 8. Penetrant testing examination

Examination was performed under natural white light with a minimum intensity of 1000 lux. The examination confirmed the presence of a relevant linear indication corresponding to a defect depth of 31.62 mm.

After confirmation of the defect by PT examination, a second excavation was performed. Material was removed by controlled grinding with an abrasive disc to a depth of approximately 42 mm from the original surface. This corresponds to the confirmed defect depth (31.62 mm) plus additional material to ensure complete removal of the discontinuity and any affected base material. This corresponds to the confirmed defect depth (31.62 mm) plus additional material to ensure complete removal of the discontinuity and any affected base material.

After completion of the second excavation and final surface preparation, a repeat Liquid Penetrant Examination was performed. No rejectable indications were detected. Evaluation was performed in accordance with the acceptance criteria applied in accordance with ASME B31.1.
