# CASE STUDY ON THE USE OF ADVANCED PHASED ARRAY ULTRASONIC TESTING METHOD ON LIMITED ACCESS T-JOINT WELDS MADE OF P91 STEEL

**Abstract:** *This paper evaluates the performance of ultrasonic testing using the advanced Phased Array Technique (PAUT) applied to T-branch welded joints with unilateral access. The base material of the components forming the welded assembly is the thermally resistant martensitic steel grade P91 (9Cr1MoVNbN). The welding processes used to fabricate the assembly were TIG (Tungsten Inert Gas) for root pass deposition, and SMAW (Shielded Metal Arc Welding) for filling the joint. The quality assessment aimed to analyze the welding-induced imperfections, considering the known susceptibility of this material to creep failure during prolonged service at temperatures of 300–500°C, which can lead to aging effects, diffusion of chemical elements, and microstructural degradation. Due to geometrical constraints and limited accessibility imposed by the pipe system configuration containing the examined welded joint, a single-direction Phased Array Ultrasonic Testing (PAUT) inspection (unilateral scan) was selected. Consequently, the inspection represents a deviation fr

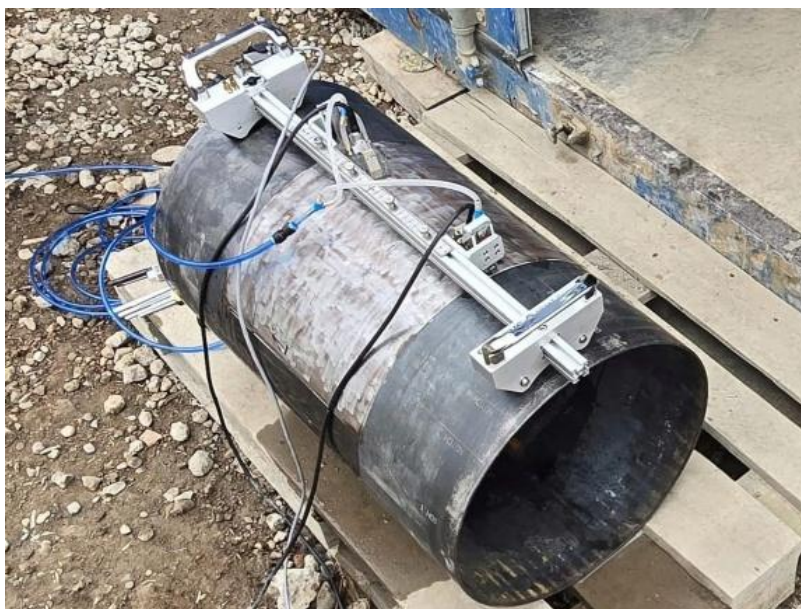
Figure 4. PAUT qualification block

Table 4 presents the required reflectors for a single-sided examination, including their theoretical dimensions and the actual dimensions achieved after mechanical preparation, Figure 4 shows the actual reference block, and Figure 5 shows the positioning of the reflectors on the qualification block, referenced to the imaginary weld central axis.

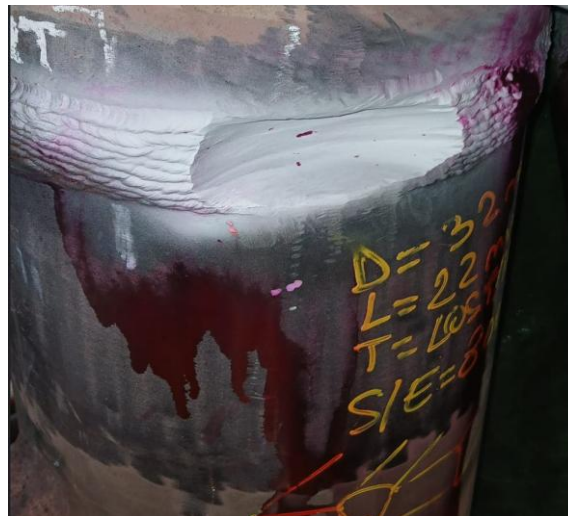
Overall, the parameters obtained from the examination confirm the presence of a structurally significant imperfection located on the far side of the joint relative to the probe position, demonstrating the effectiveness of the method in detecting and characterizing defects in limited-access T-joint weld configurations. To confirm the existence of the identified defect and validate the PAUT examination, penetrant testing (PT) was performed after excavation reached the indicated location, confirming the defect, as shown in Figure 8.

Figure 8. Penetrant testing examination

Examination was performed under natural white light with a minimum intensity of 1000 lux. The examination confirmed the presence of a relevant linear indication corresponding to a defect depth of 31.62 mm.
